Brooks Architectural, Inc.

March 1, 2018

Weesaw Township
13518 State Street
PO Box 38
New Troy, MI 49119

Re: Roof Ventilation Report

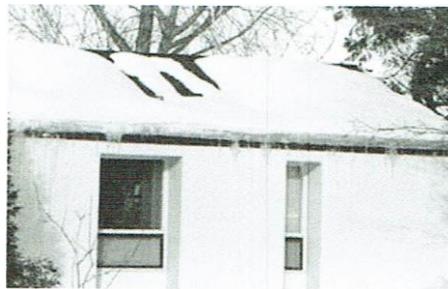
The photograph below illustrates unusually high heat loss from the roof. There is very little snow left on the roof and at its edge is both an ice dam and a "beautiful" row of icicles.

The unusually high heat loss on this roof has caused both an ice dam and icicles.

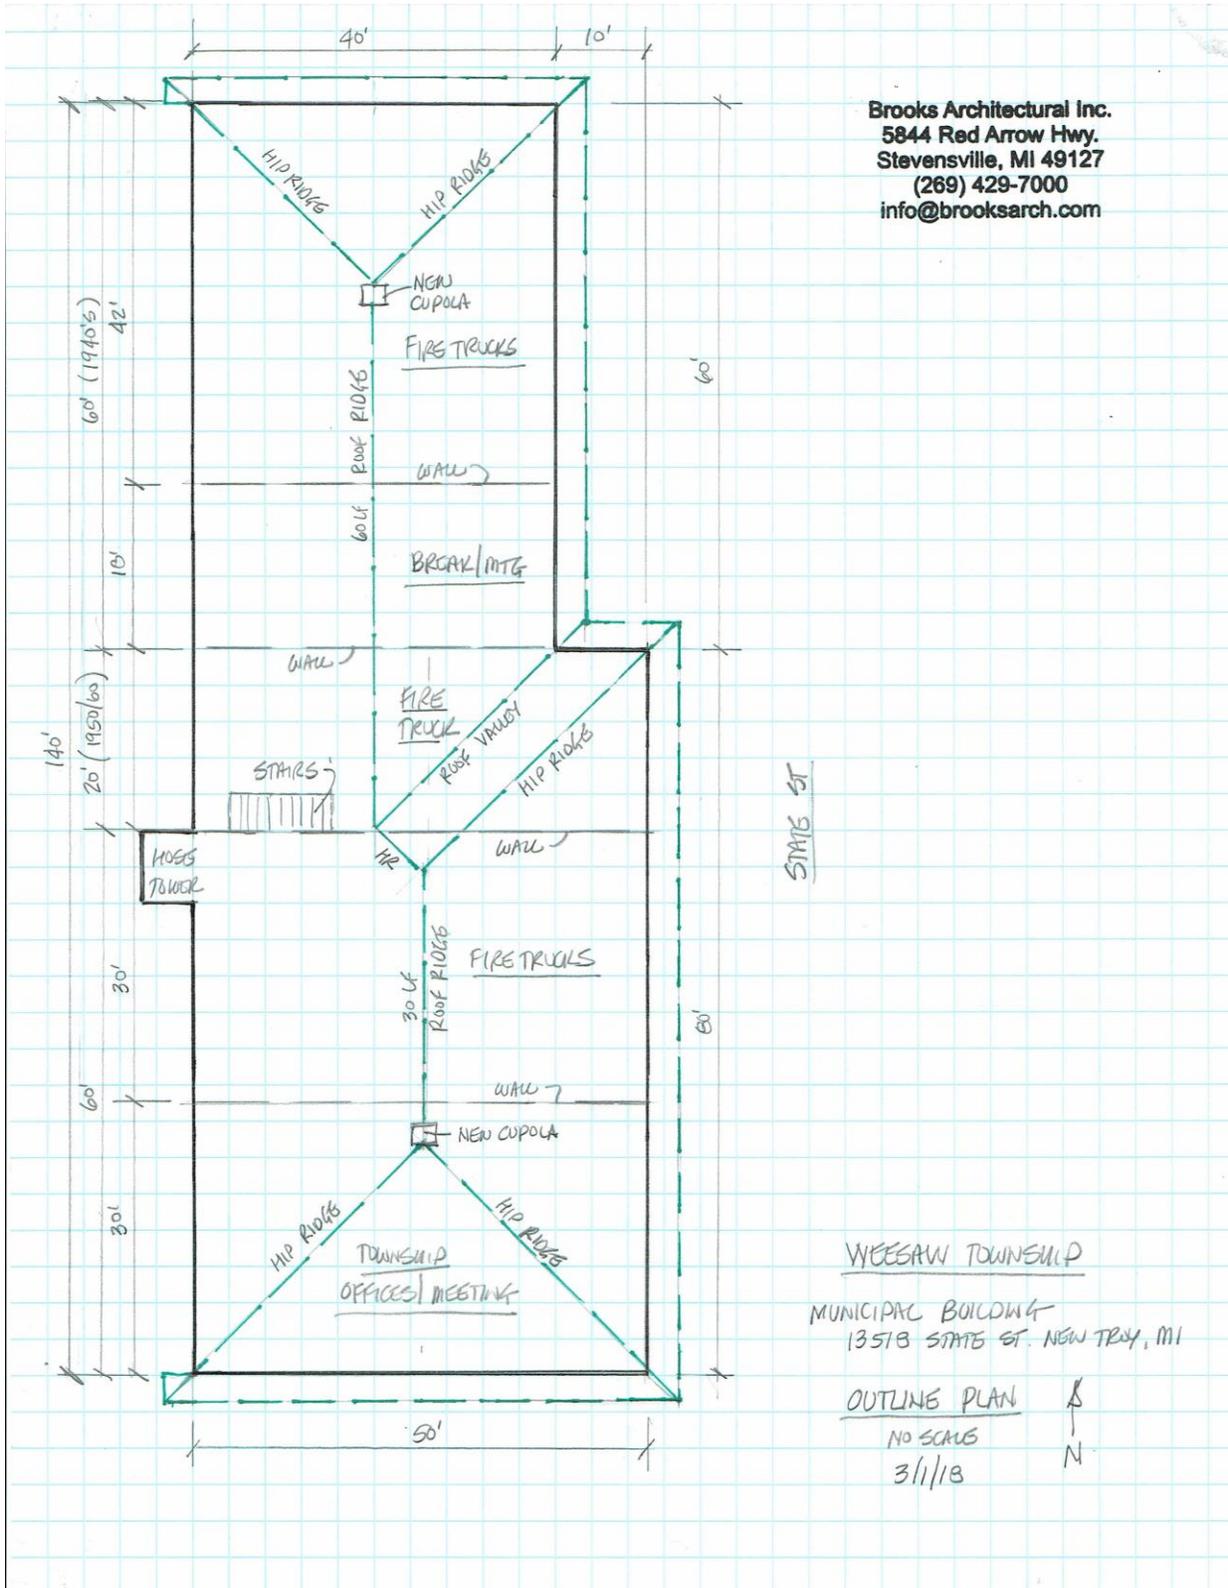
OUTLINE PLAN
 NO SCALE
 3/1/18

I have attached a simplified drawing of the plan of the building (Attachment B). The green lines are the roof. The building has been constructed in three sections. The first was the original north section which houses fire trucks and vehicles as well as a break room. This is 40' x 60' (2400 SF) and had an original flat insulated roof. The second was a 20' addition to the south of the original. This houses a fire truck bay and the stair access to the attic. This is 20' x 60' (1200 SF) and had an original flat insulated roof. The third section is the south portion which houses two fire tuck bays, the hose tower and the township offices and meeting room. This 50' x 60' (3000 SF) addition also had a flat roof with minimal roof insulation. The total for the entire building is 6600 SF (square feet). At some time a shingled wood roof truss system with mansard sidewall section was installed over the flat roofs. This created a 3' deep soffit on portions of the building.
