Brooks Architectural, Inc.

March 1, 2018

Weesaw Township
13518 State Street
PO Box 38
New Troy, MI 49119

Re: Roof Ventilation Report

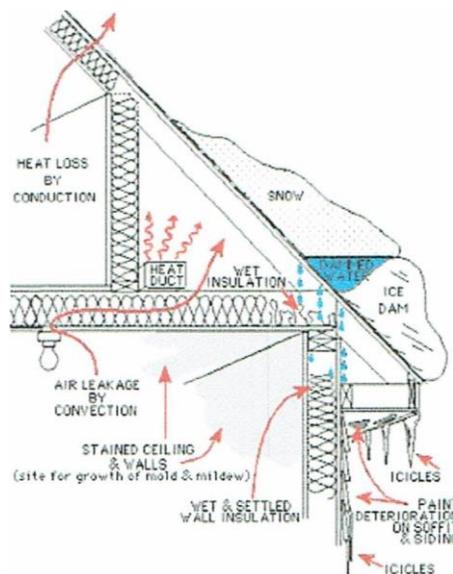
Figure 1

There is another type of convection that transfers heat to the attic space and warms the roof. In Figure 1, the winding arrow beginning inside the house and going through the penetration in the ceiling, from the light to the attic space, illustrates heat loss by air leakage. In many homes this is the major mode of heat transfer that leads to the formation of ice dams.

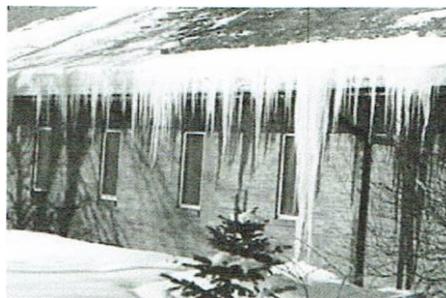
The unusually high heat loss on this roof has caused both an ice dam and icicles.
